Case report: Regenerative (GBR),  
implantological, and restorative  
reconstruction after four years.

## P ERIIMPLANT HARD/SOFT-TISSUE ESTHETICS FOR THE LONG TERM IN SINGLE-TOOTH IMPLANTS AFTER AUGMENTATION WITH BOVINE BONE REPLACEMENT MATERIAL

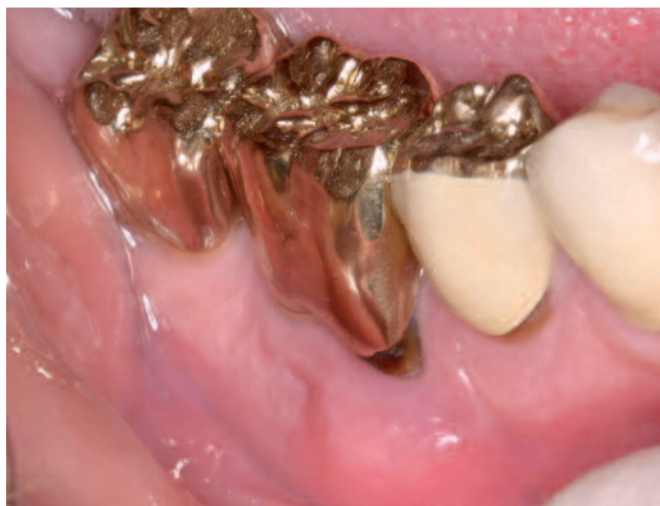
Fig. 1: Clinical situation prior to extraction

17 years after this treatment, the patient presented with symptoms at tooth 19. The clinical examination indicated a pressure-sensitive swelling in the tooth 19 region (Fig. 1). Probing enabled us to determine the presence of an open class II bifurcation. The radiograph (Fig. 2) revealed a large cavity around the root tip.

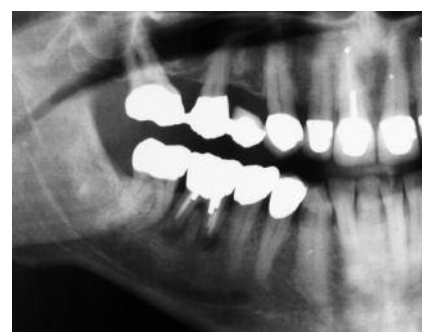
Fig. 2: Radiograph prior to extraction

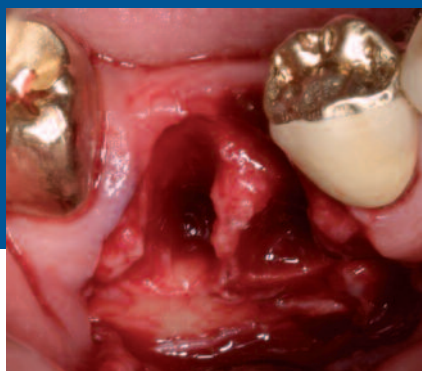
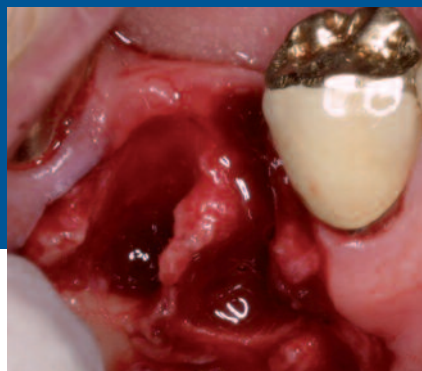
*Figs. 3 and 4: Bone loss after extraction of tooth 19*

Tooth 19 was extracted along with the granulation tissue. This revealed a significant defect in the buccal alveo-

lar ridge (Figs. 3 and 4). Directly after extraction and removal of the inflamed tissue, a split flap, large enough to cover the alveolus and bone replacement material without tension, was prepared. The bone filler used was exclusively Bio-Oss. The augmentation was covered with a Bio-Gide double-layer resorbable membrane. The membrane was attached with two titanium nails apically and lingually with a 6/0 Gore mattress suture. Suturing was performed with a 6/0 Prolene running suture and a Gore 6/0 fixation (mattress) suture.

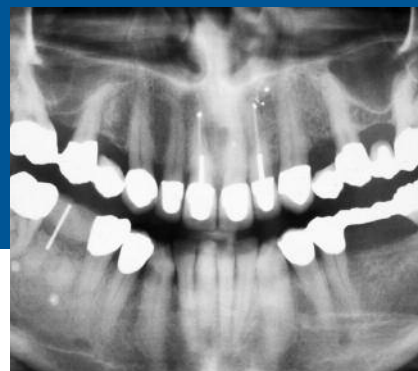
*Fig. 5: Panoramic image eleven months after GBR with 11-mm measuring wire*

Eleven months later, a CAMLOG® SCREW-LINE implant, diameter 6.0 mm, length 11 mm, was inserted at tooth 19 (Figs. 5–9). After implant insertion and a healing phase of four months, the implant was exposed and a cylindrical healing cap was screwed in (Fig. 10).

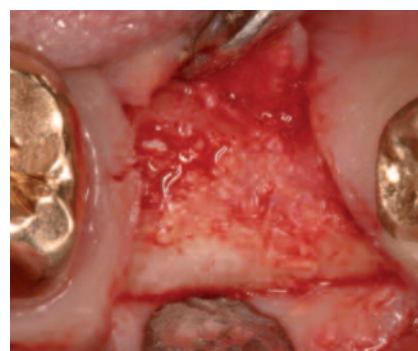
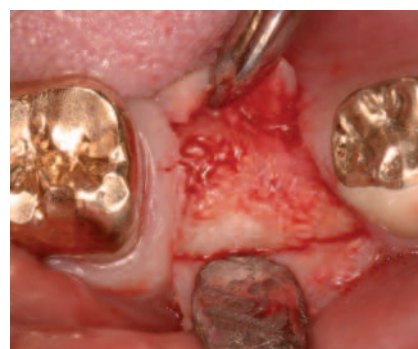
*Figs. 6 and 7: Clinical situation 11 months after GBR*

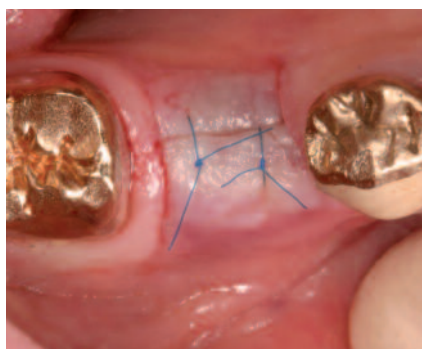
*Fig. 8: Post-implantation suturing*

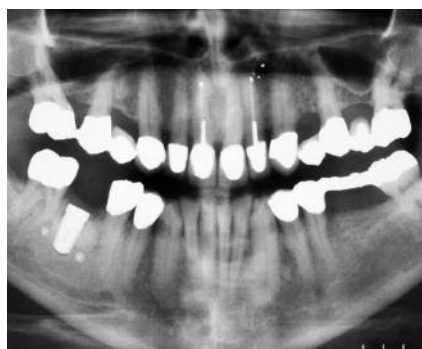
*Fig. 9: Post-implantation panoramic radiograph*

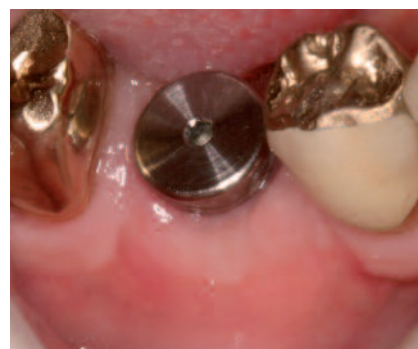
*Fig. 10: Healing cap, cylindrical, one month in place*

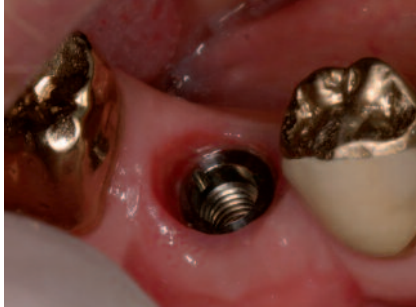
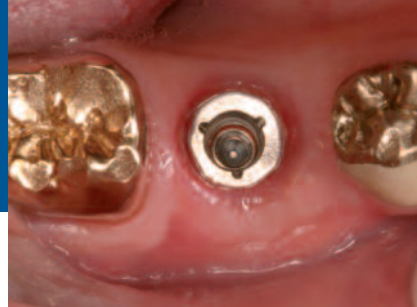
*Figs. 11 and 12: Soft-tissue contour around the implant following removal of the healing cap*

The healing cap was removed again after one month (Figs. 11 and 12). The transfer impression was made with a closed tray, and the wax-up was prepared (Figs. 13–17).

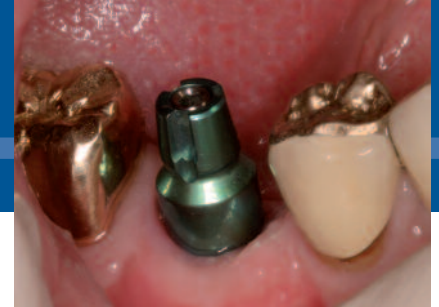
*Fig. 13: The inserted impression post, closed tray*

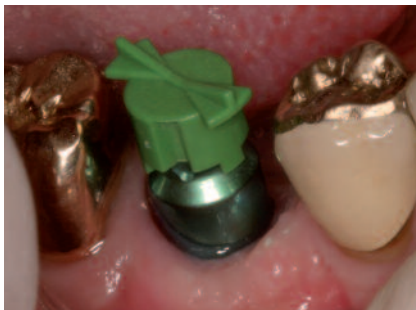
*Fig. 14: Impression post, closed tray, with impression cap mounted on top*

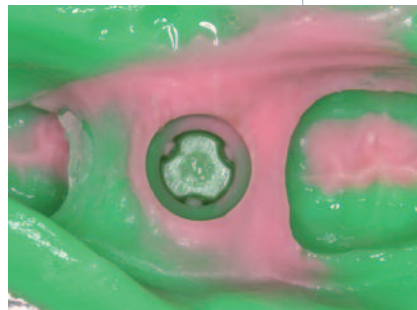
*Fig. 15: View from above of the green color-coded impression cap. Apically, the pink impression material forms a correct border around the impression cap*

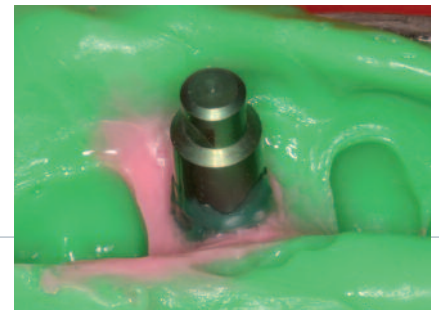
*Fig. 16: The inserted lab analog*

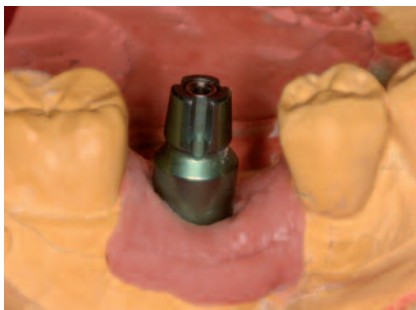
*Fig. 17: Master cast with gingival mask*

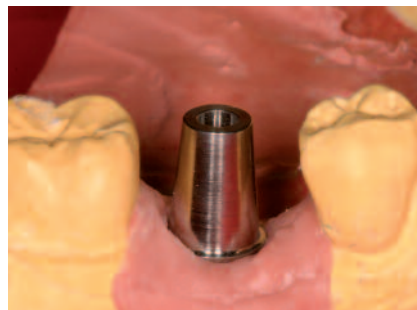
*Fig. 18: The unfinished titanium abutment*

Individualisation of the titanium abutment and fabrication of the final metal-ceramic crown were performed in the dental office laboratory (Figs. 18–22). Next followed the try-in and attachment of the implant-supported crown (Figs. 23–25).

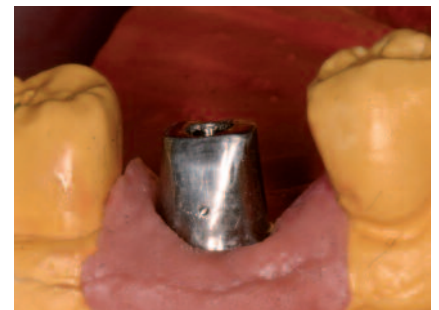
*Fig. 19: The customised titanium abutment*

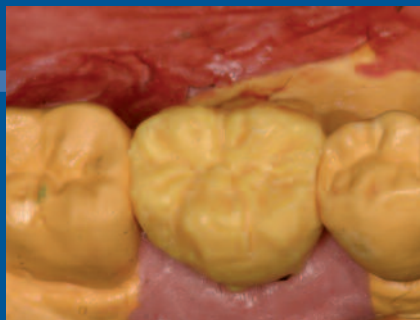
Fig. 20: Wax-up of tooth 19

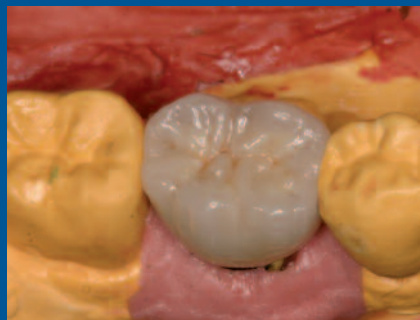
Fig. 21: Form-fit transfer of the wax-up in metal ceramic

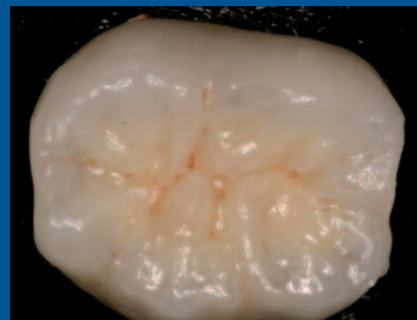
Fig. 22: Occlusal view ceramic

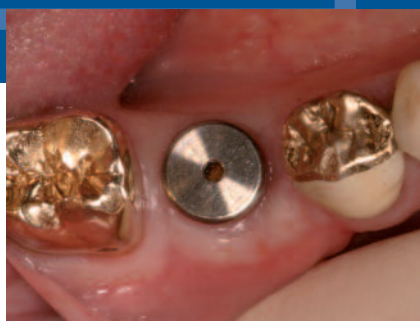
Fig. 23: Healing cap and soft-tissue area prior to insertion of the crown

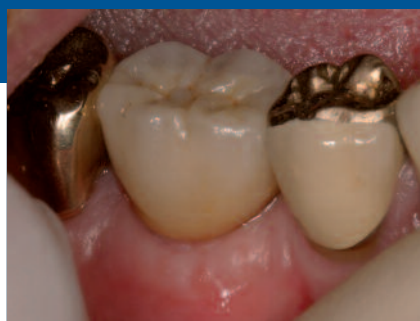
Fig. 24: Metal-ceramic crown in situ directly after insertion

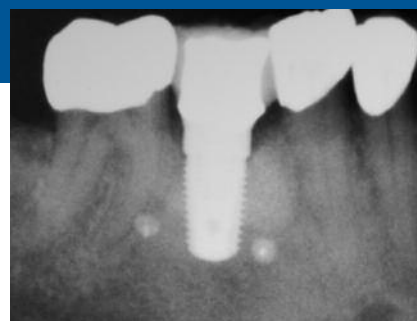
Fig. 25: Follow-up panoramic image after crown insertion

The titanium nails were left in place after discussion with the patient (see Fig. 25).

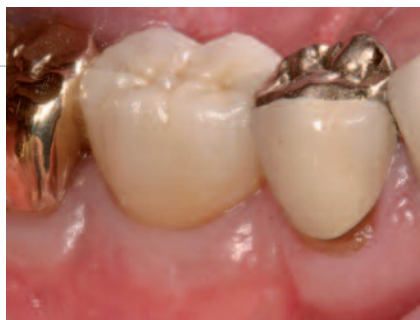
Fig. 26: Four years after insertion, the periimplant result is clinically stable and the gingiva is free of inflammation and well attached

Four years after the insertion of the crown, a clinical and radiographic follow-up exam with pocket depth probing was performed and documented (Figs. 26–28). A stable peri-implant situation, non-inflamed gingiva, normal pocket depths (buccal pocket depth measured in the area of the defect: 2 mm) and no loss of vertical bone level (so far as a radiograph permits this to be stated) were found. The radiograph also showed residual Bio-Oss.

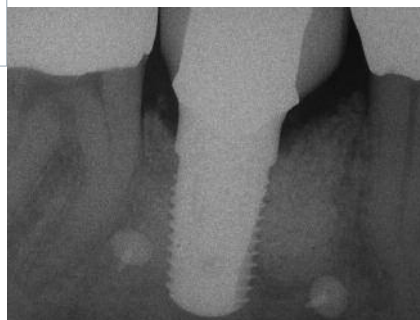
Fig. 27: Radiographic follow-up four years after insertion shows the apparent stability of the periimplant tissue (see Fig. 26)

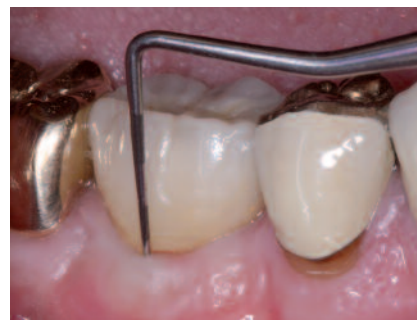
Fig. 28: The buccal pocket depth four years after the insertion measures 2 mm in the defect area
