Bone block, implant, split-thickness flap, reconstruction and restoration

Restoring a single-tooth space

Dr Hermann Derks and Wilfried Lesaar, Emmerich/Germany

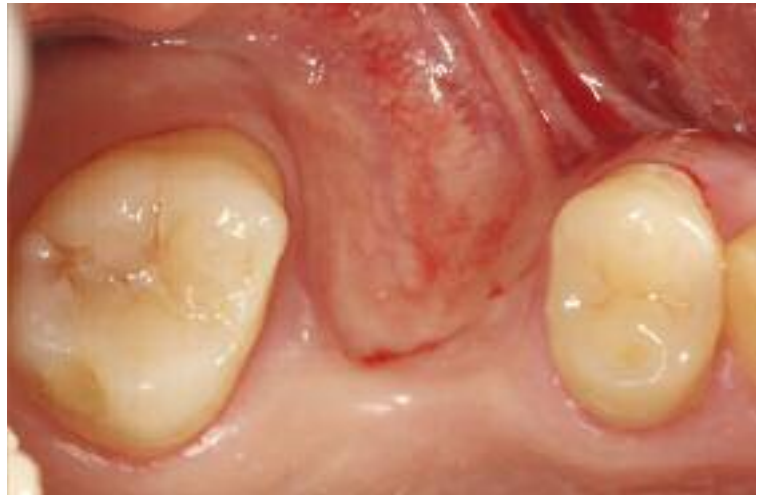
Fig. 1 Clinical baseline situation. A buccal advancement flap according to Rehrmann had been created several years previously.

A 29-year-old male patient was referred to our office for restoration of the missing tooth 16. The patient's medical and dental history was normal. The third molars were absent; several teeth have been restored with adequate fillings. The occlusion was stable and normal. The periodontal tissues were free of inflammation. Tooth 16 had been extracted several years previously. A perforation of the maxillary sinus had been closed with a buccal advancement flap according to *Rehrmann*. Because the oral mucosa had been extensively mobilized at the time, the alveolar ridge at the site was covered with mobile mucosa, reaching all the way to the palatal side at the time of the baseline examination (Fig. 1). A vertical and horizontal (mesial) osseous defect was diagnosed radiologically (Fig. 2).

The baseline photograph shows the mobile mucosa covering the entire erstwhile extraction socket (see Fig. 1). The importance of the presence of keratinized mucosa at the implant neck has not been described conclusively in the literature. So far there have been no scientific data suggesting reduced success or survival rates for implants placed in mobile mucosa. However, clinical practice has demonstrated the advantages of keratinized mucosa, not least with regard of oral hygiene. It is therefore hardly surprising that the presence of mobile mucosa has been described as a risk factor in mucositis [8], although not in peri-implantitis [8,9]. In the case presented here, creation of a split flap produced a 2 to 3 mm wide zone of keratinized mucosa. ■

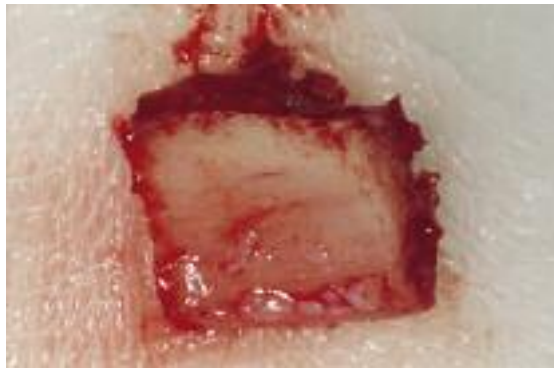
Fig. 3 A bone block was piezosurgically harvested at site 48.

A bone block was harvested piezosurgically at site 48 (Fig. 3) after an extensive flap had been prepared at site 16 to accommodate this bone block. When the bone was exposed at the implant site, the pre-existing perforation of the maxillary sinus turned out to be covered with soft tissue only. To maximize the contact area with the bone at the augmentation site, the bone block was prepared appropriately. The graft was

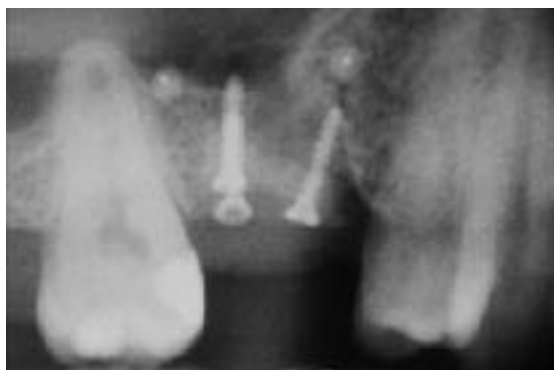
Fig. 5 Control radiograph following the fixation.

secured with three screws (OsteoMed) (Figs. 4 and 5). A membrane (BioGide) was buccally anchored using two bone pins (Friatec). The remaining undercut were filled with a bone substitute (BioOss) (Fig. 6). The membrane foil was secured palatally with a 6-o Gore-Tex suture (Fig. 7), whereupon the mucosal flap was mobilized so the graft could be covered without tension and sealed to prevent saliva from entering (Fig. 8).

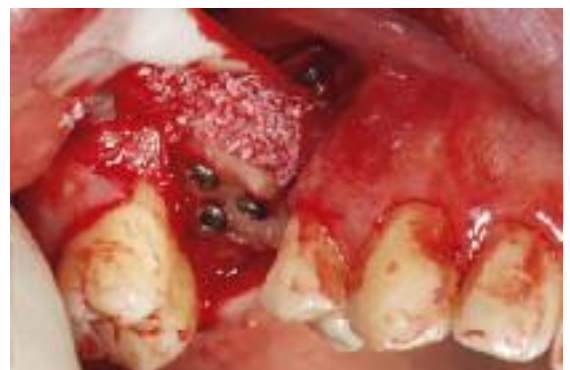
Fig. 6 A small pin and bone substitute were used to stabilize the membrane.

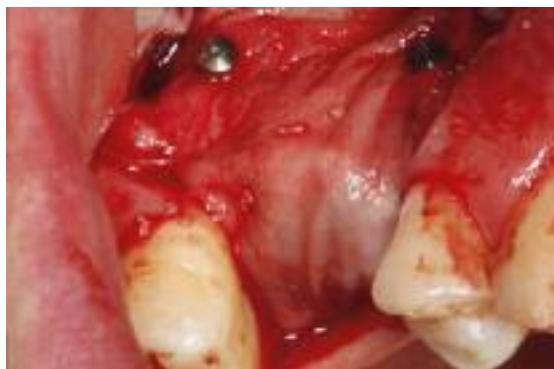
Fig. 7 The graft completely covered the site and was secured by a palatal suture.

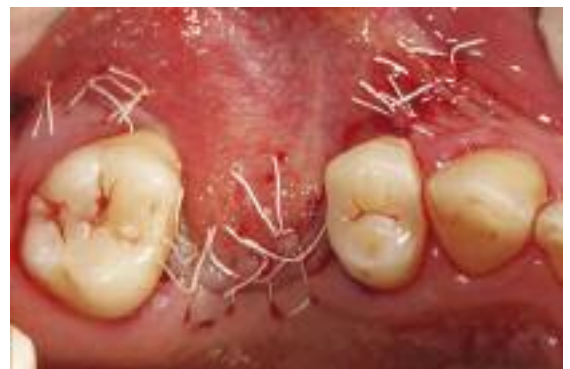
Fig. 8 The suture was free of tension and impervious to saliva.

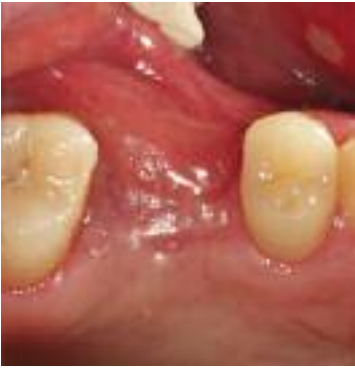
Fig. 9 The alveolar ridge prior to reentry.

The first healing phase was uneventful (Fig. 9). The screws that held the graft in place were removed (Fig. 10), and the patient was ready for implant insertion (SIC) (Figs. 11 and 12). To improve the soft-tissue situation, a split flap was used (Figs. 13 and 14). The objectives were to cover the implant completely (Fig. 15) and to harvest keratinized mucosa on the buccal aspect of the future crown (Fig. 16). Figure 17 illustrates the situation two weeks after the surgical intervention.

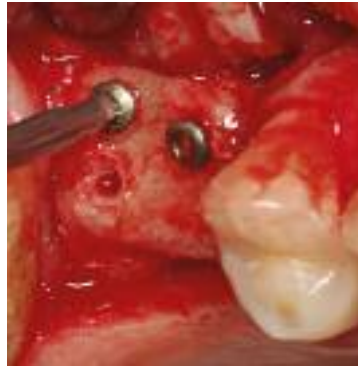
Fig. 10 The screws were removed and ...

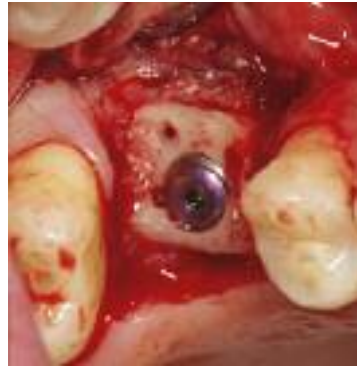
Fig. 11 ... an implant was inserted.

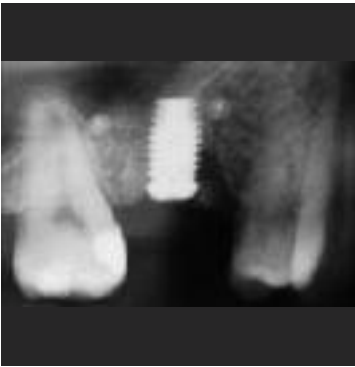
Fig. 12 Control radiograph following the implantation.

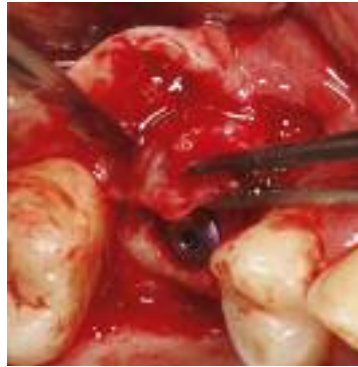
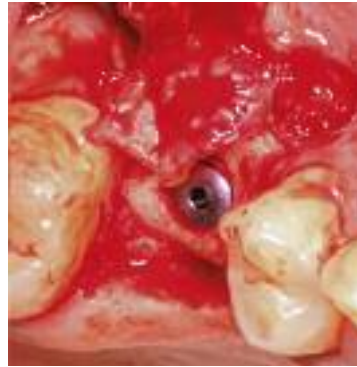
Figs. 13 and 14 Creation of a split-thickness flap.

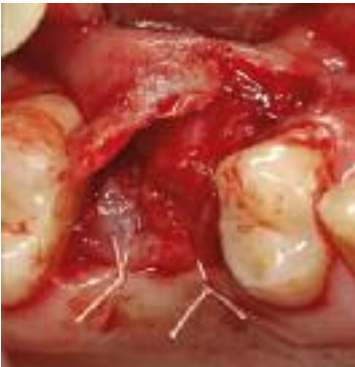
Fig. 15 The sutured internal flap ...

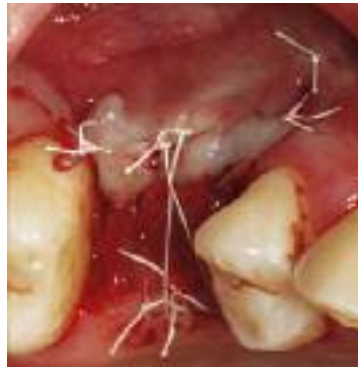
Fig. 16 ... and the relocated external flap.

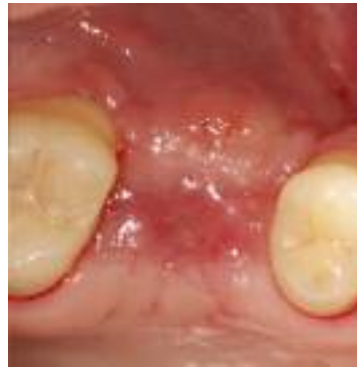
Fig. 17 Two weeks after the procedure.

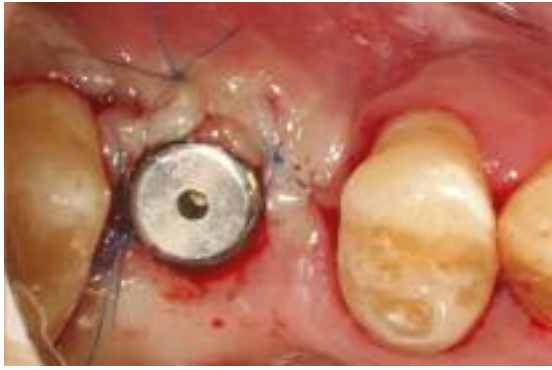
Figs. 18 and 19 Connection of the healing abutment and subsequent control radiograph.

A healing abutment could be connected three months later (Figs. 18 and 19). Figure 20 shows the position of the healing abutment after six weeks in situ. At the same appointment, an open-tray impression was taken for the definitive crown. The crown was fabricated conventionally (Figs. 21 to 23) and cemented with Harvard cement at delivery (Figs. 24 and 25).

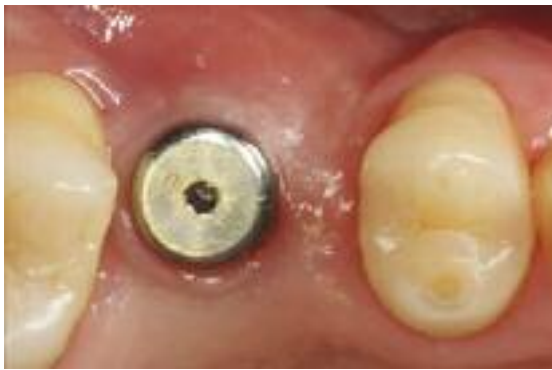
Fig. 20 The healing abutment after three months.

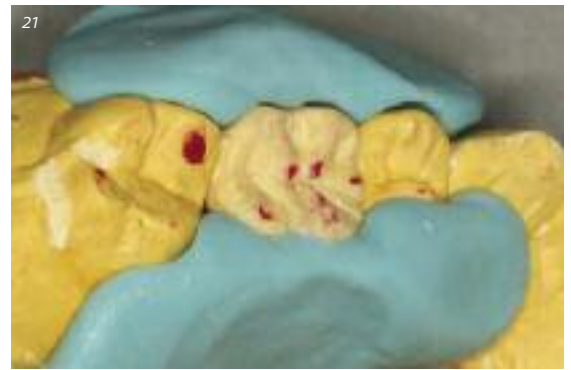
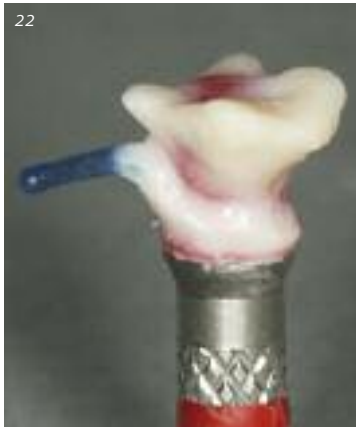
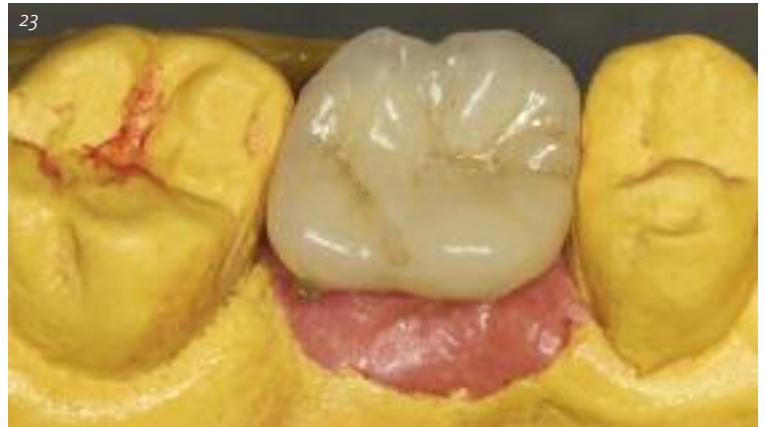
Figs. 21 to 23 The crown was fabricated using conventional methods.

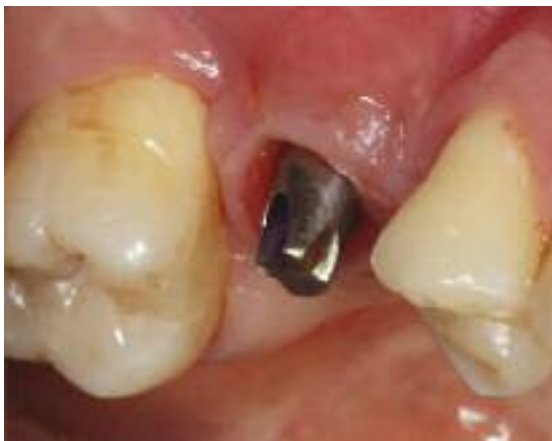
Fig. 24 The definitive abutment was connected prior to the delivery of the crown.

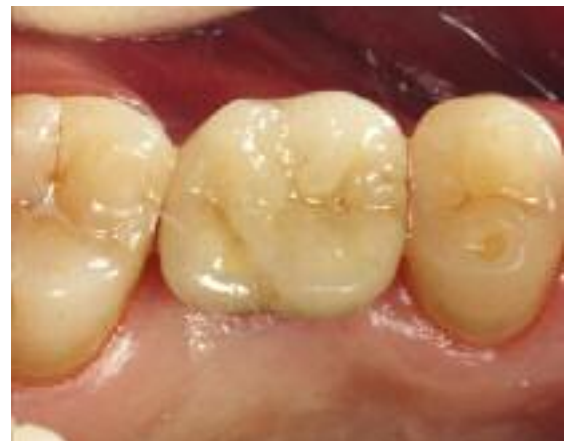
Fig. 25 The cemented crown on the implant at site 16.

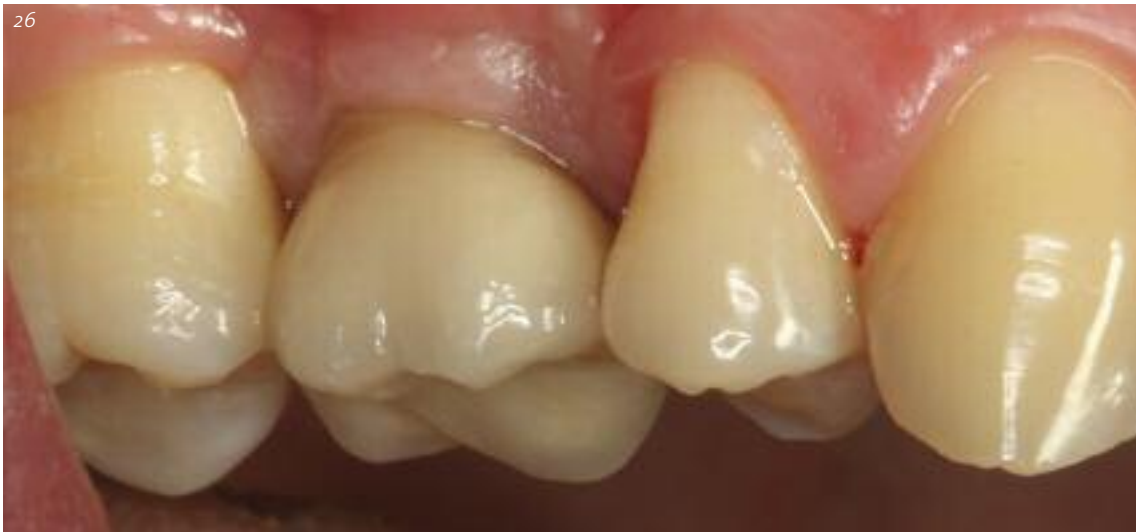
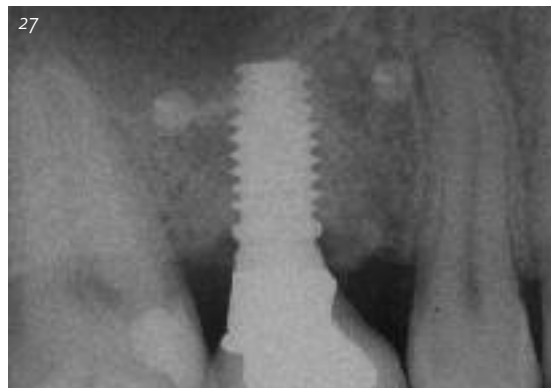
*Figs. 26 and 27
At two years
postoperatively,
the situation was
stable.*

At two years postoperatively, the situation was stable. By agreement with the patient, the bone pins were left in place (Figs. 26 and 27).
